Reference: Quarterly Progress Report
Consent Agreement and Final Order (CAFO)
Docket No. RCRA-05-2014-0013
Project No. 242933.0000

PROGRESS REPORT – Fourth Quarter 2015
Canton Drop Forge, Inc.
Canton, Ohio
U.S. EPA ID No. OHD00446S142

ATTACHMENT 3
POND NO. 2 PHOTOS

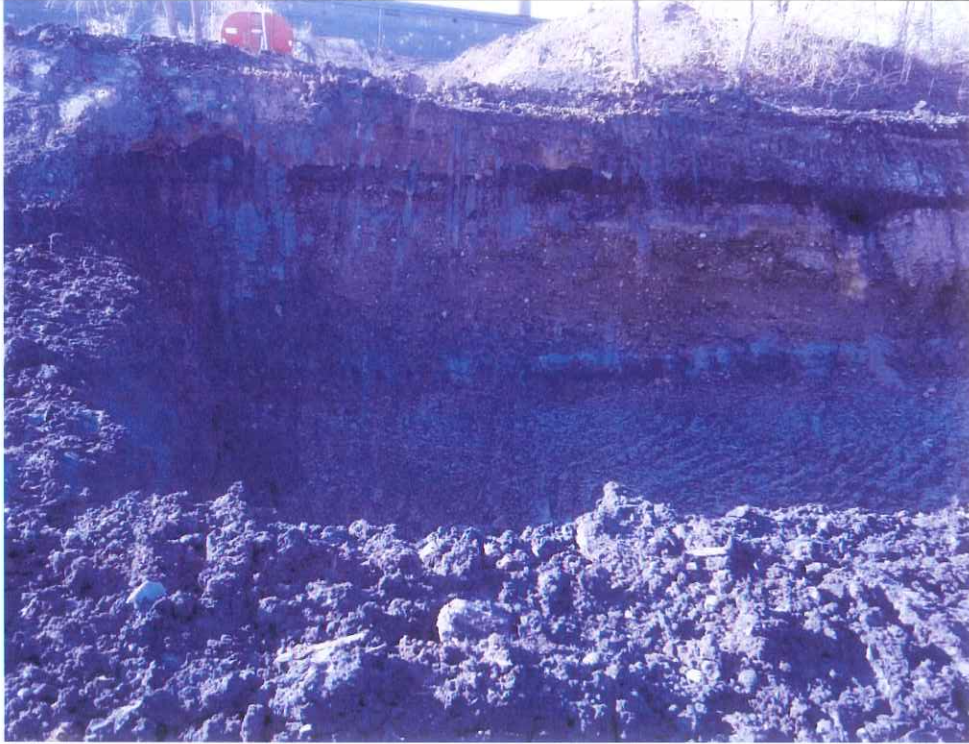
Photo 1: West / Northwest Pond 2 (11/25/15)

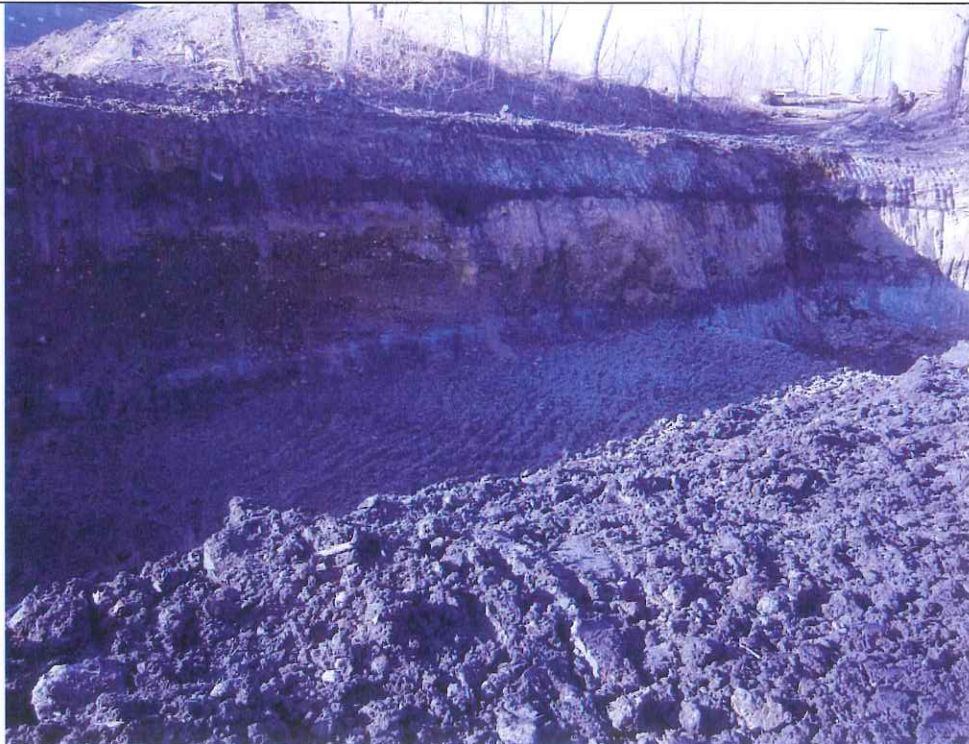
Photo 2: West / Northwest Pond 2 (11/25/15)

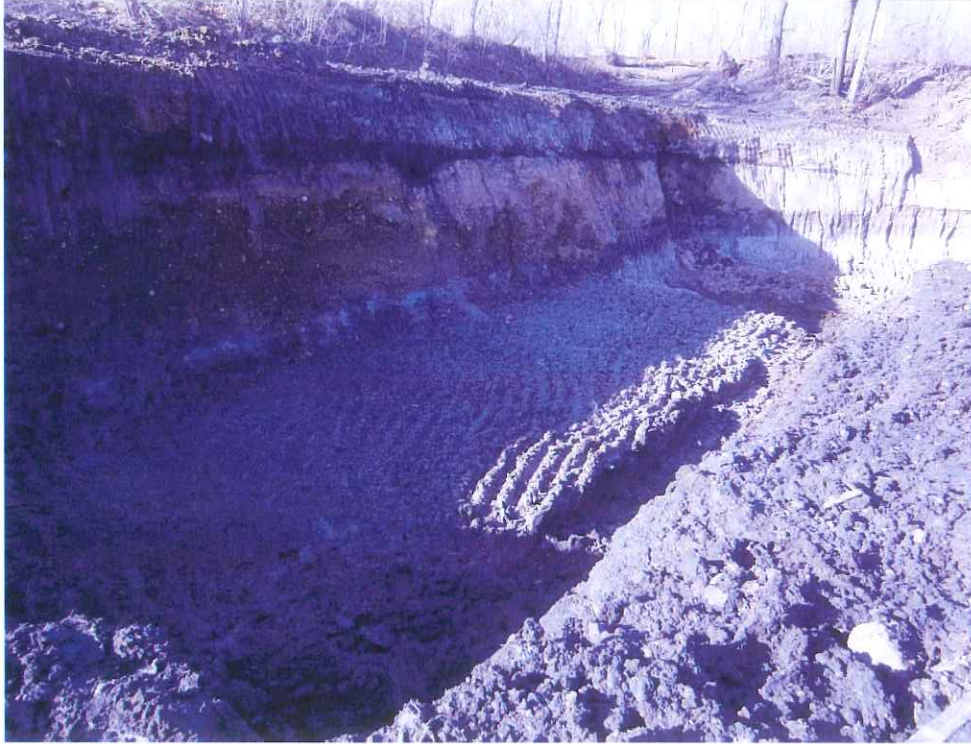
Photo 3: West / Northwest Pond 2 (11/25/15)

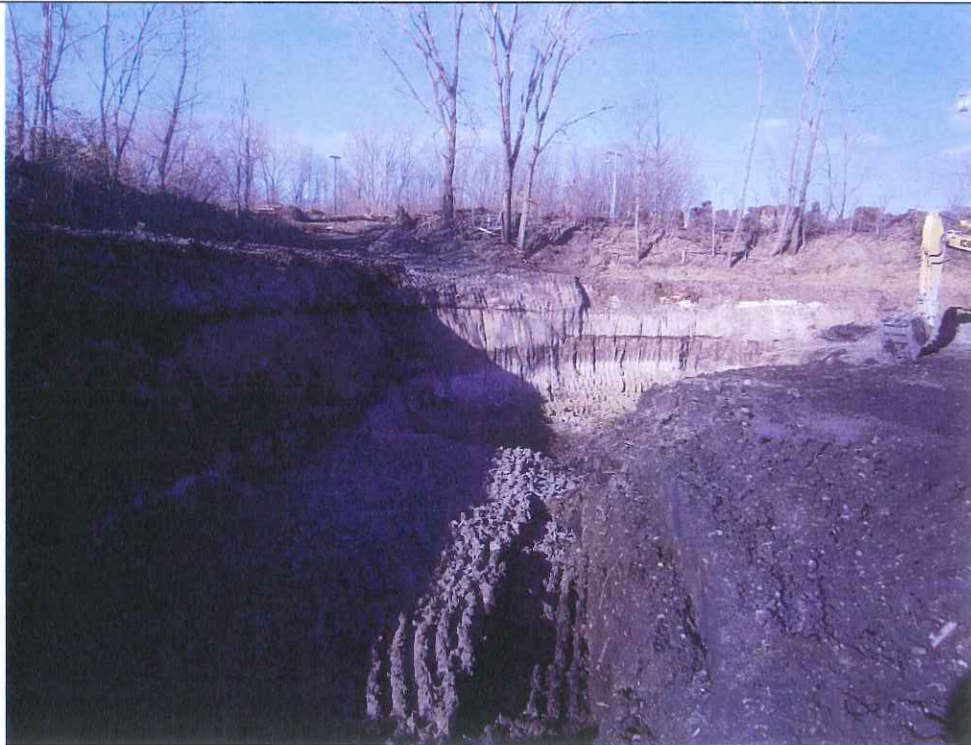
Photo 4: West / Northwest Pond 2 (11/25/15)

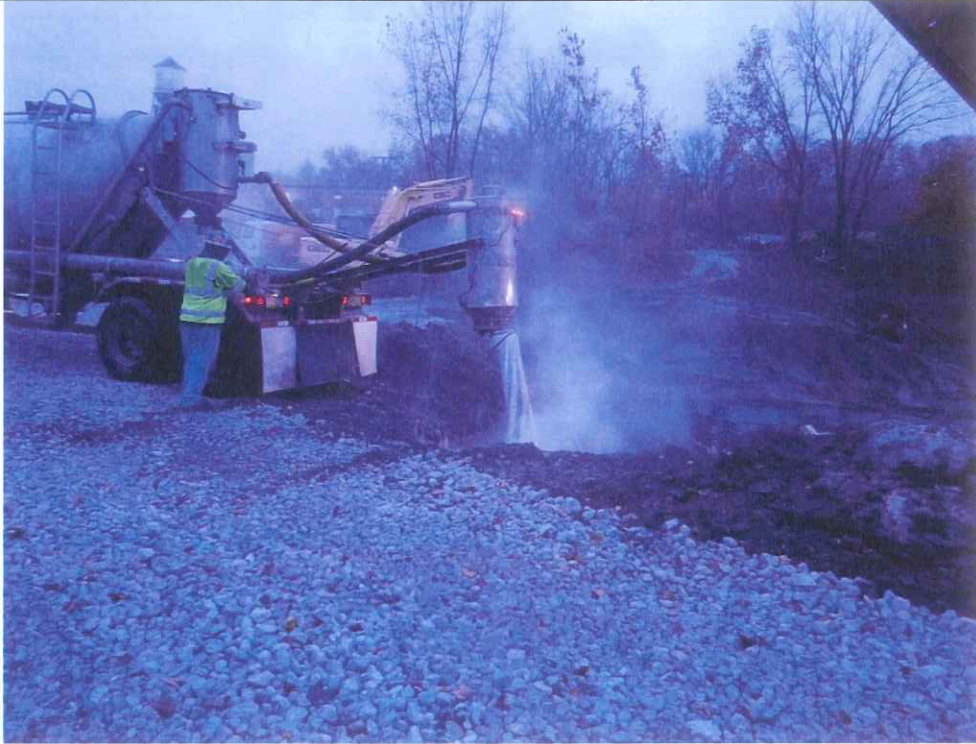
CDF was notified by Ohio EPA on October 27, 2015 that they had received dust complaints. It was presumed that the dust was due to the mixing of Calciment® in the soil. Calciment® is used as a drying agent for solidification of the bottom material prior to off-site disposal.

Photo 1: Caliment Application (10/28/15)

Calciment® has the consistency of fine powder and traditional dust control methods (e.g., wetting) contradict the objective of the product as a drying agent. CDF was advised to note wind velocity and direction to implement adequate control measures. Adjustments to operations were made accordingly for dust and odors as needed. The provider contracted by CDF utilizes a cyclone attachment on the vehicle to minimize the Calciment dust. Photos are included in Attachment 4. CDF monitored the entire transfer operation on October 28, 2015 and minimal dust was observed. Specifically, dust did not travel south towards Southway Street or the neighboring homes across the street. Photos are included in Attachment 4. Per a phone call with Ohio EPA on October 30, 2015, CDF reviewed the current status of operations and the matter appeared to be resolved. Ron Jones of the Canton City Health Department visited CDF on October 30, 2015. CDF continues to work with the neighbors to maintain compliance and minimize the dust.

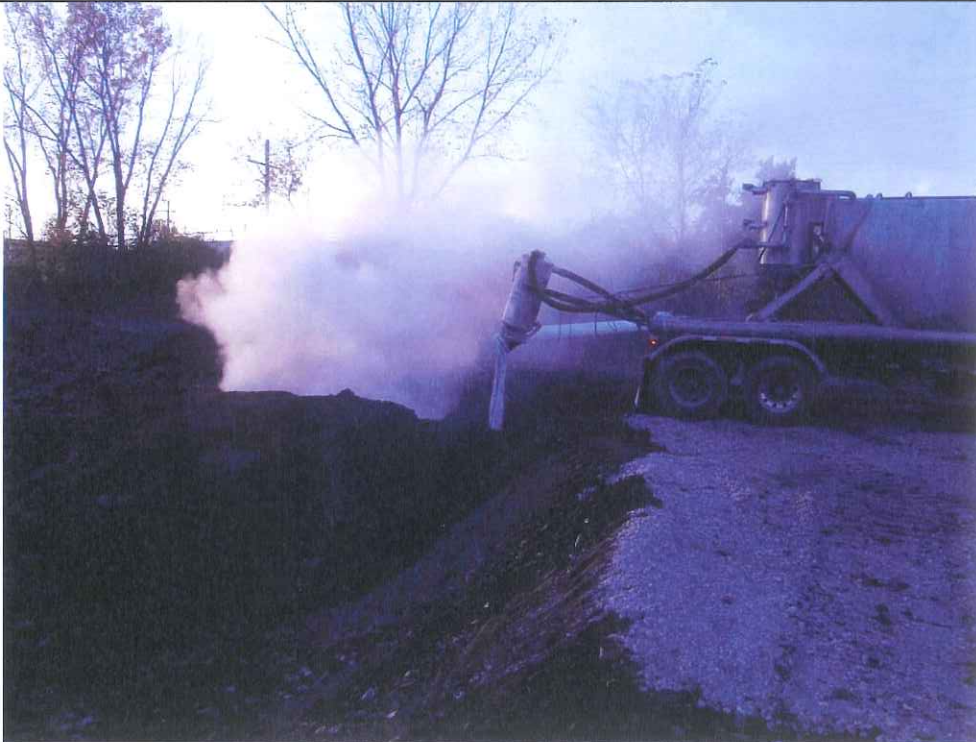
Photo 2: Caliment Application (10/28/15)
